Bowman Creek Watershed Management

Monitoring and Maintenance Plan

August 2018

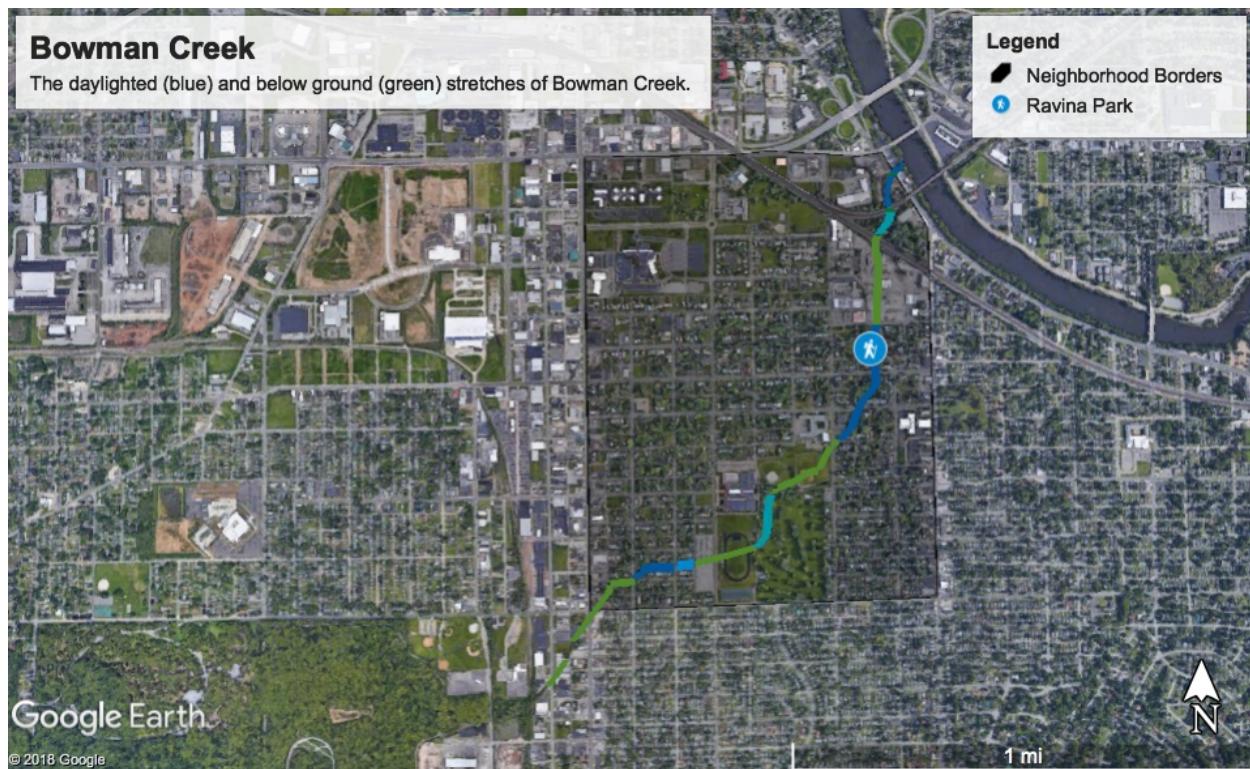
Figure 1.1 Map of Bowman Creek obtained from Google Earth Pro identifying where Bowman Creek flows through a culvert to a below ground (green lines) stretch and where the creek is above ground (blue lines). The Southeast neighborhood is identified by the shaded box.

Bowman Creek begins at Greentech Dr. where one of its tributary ditches, Auten Ditch, enters the City of South Bend. From Greentech Dr., the creek flows north-east through the Southeast neighborhood of South Bend with many stretches flowing through pipes underground or in culverts beneath the roads (Fig. 1.1) due to urban modification (Deegan 2017). The creek discharges into the St. Joseph River just southeast of E. Lincoln Way and E. Sample St.

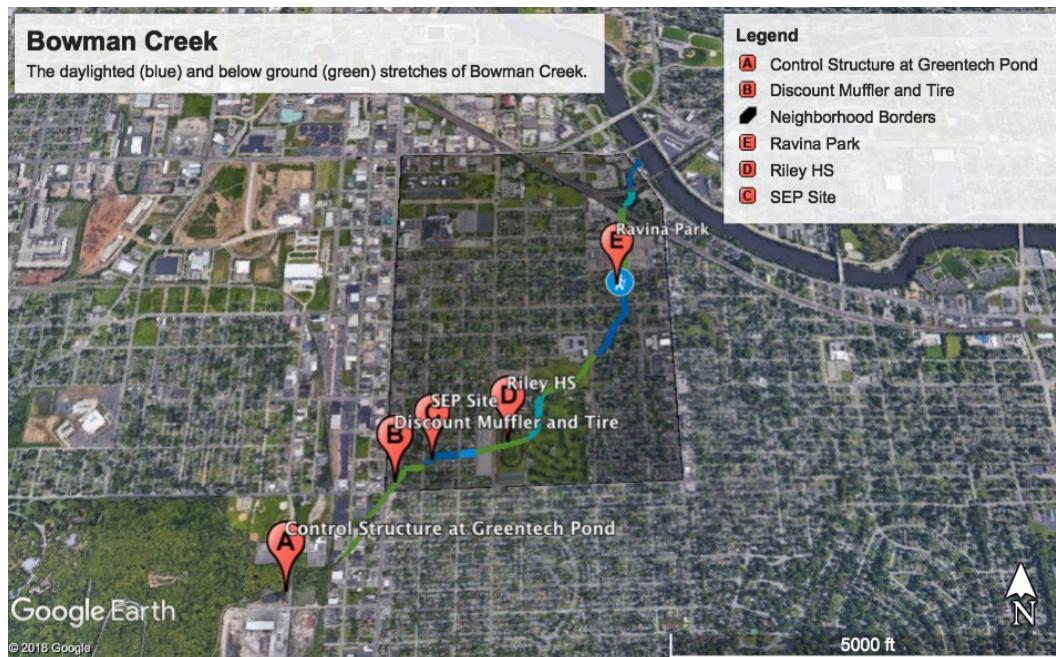
Figure 4.1. Map obtained from Google Earth Pro showing key locations.

Several key locations along Bowman Creek have been identified because they are accessible to both community residents and the City of South Bend or they are locations of ongoing and future revitalization strategies (Fig. 4.1).

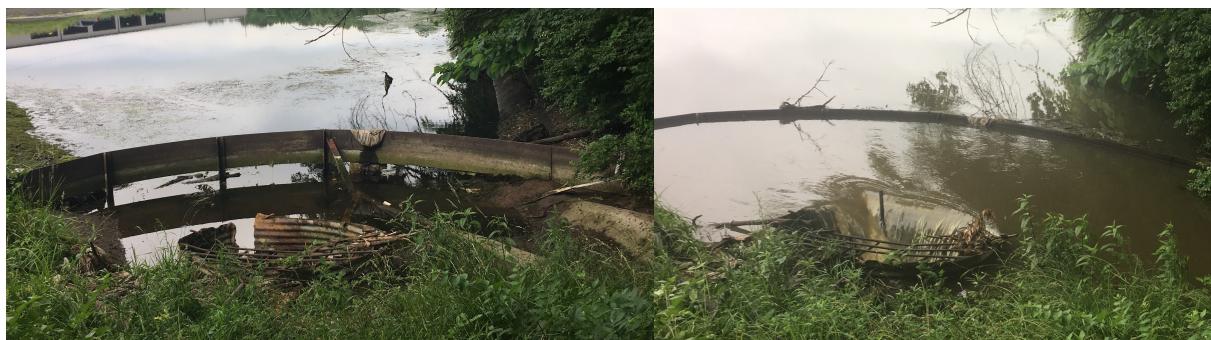
Figures 4.2.a(left) and 4.2.b (right). A higher water level in the retention pond results in drastically higher flow rates downstream due to the weir.

Auten Ditch is one of the three tributary ditches that combine to become Bowman Creek. Auten Ditch flows into a retention pond located on Greentech Dr. right at the beginning of Bowman Creek and is under ownership by Republic Waste Services. A small control structure or weir is located within the retention pond. Currently, the weir at Greentech Pond allows only a small flow from the retention pond unless the top of the weir is reached, in which case the flow is increased drastically (Fig. 4.2).

The weir prevents connectivity within the Bowman Creek watershed for aquatic species such as fish and creates unnatural flow patterns depending on the amount of water available. Extreme rain events cause a large increase in the amount of water allowed through by the control structure which can cause incising and erosion within the waterway. The presence of an outflow

culvert downstream of the weir's entrance presents the danger of undercutting of the creek bed due to erosion. Undercutting not only decreases the velocity of the creek and creates a stagnant area but also compromises the integrity of the culvert itself over time. The dangers of weir failure and undercutting at this point include sediment loads washing downstream and burdening ecosystems and compromising the integrity of the road over the culvert.

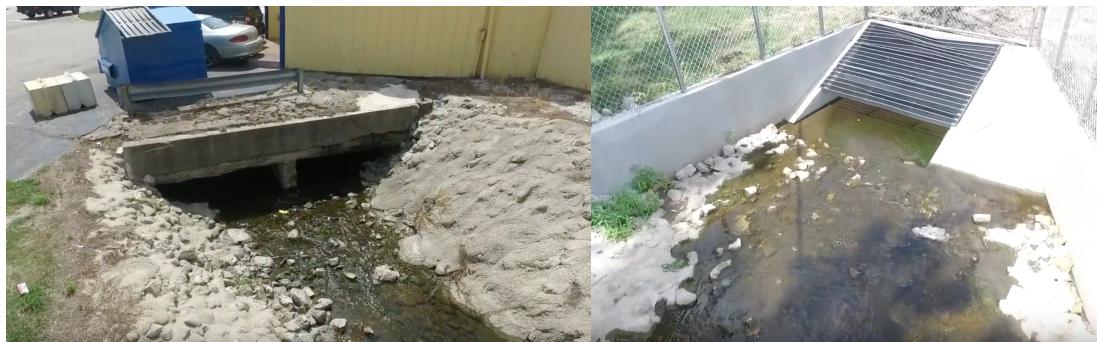
Figure 4.3 Upstream and downstream views of Bowman Creek near Discount Muffler and Tire

Located at Fox St. and Michigan St., Bowman Creek becomes above ground and runs along the Discount Muffler and Tire shop before flowing underneath Fox St. as shown in Figure 4.3.

The creek channel is surrounded by concrete banks in order to prevent erosion. The tunnel entrance at Fox St. contains a bar screen and the tunnel entrance has been recently redone to prevent flooding. In February, Bowman Creek flooded at this location and damaged a nearby house and sidewalk. This location is accessible and has had a history of flooding, indicating that there is a great need to frequently monitor and maintain the state of the Fox St. tunnel entrance.

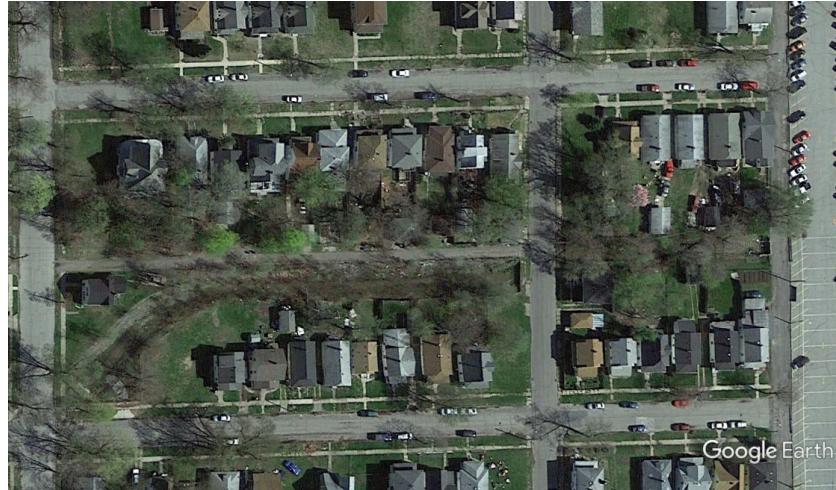
Figure 4.4. Aerial photo of SEP site

The CoSB in partnership with BCe2 has recently undertaken a Supplemental Environmental Project (SEP) involving the beautification and revitalization of a stretch of Bowman Creek that runs through the Southeast neighborhood. The SEP site is located between S. St. Joseph St. and Carroll St. off of E. Fox St. and has a project budget of \$30,000.

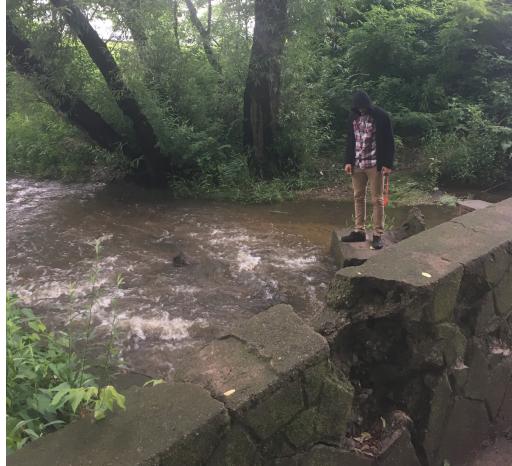
Figure 4.5. The old concrete bridge contains two culverts, but these are not always enough to handle the flow.

Ravina Park is located at Indiana Ave. at Lebanon St. Bowman Creek runs through the park and residents are able to walk down stairs that lead to the creek bank. Remnants of a concrete bridge shown in Figure 4.5 that was destroyed by a tree during a heavy storm block the channel and limit its capacity due to two remaining culverts.

During heavy flow, the creek sometimes flows around this concrete structure and washes out the surrounding banks. Future plans for this broken bridge include removing the concrete and repairing sidewalks around the block to provide Americans with Disabilities Act-compliant access to the area. The CoSB is also completing a project at Ravina Park in 2018 to stabilize the creek banks.
